Home Inspection Report

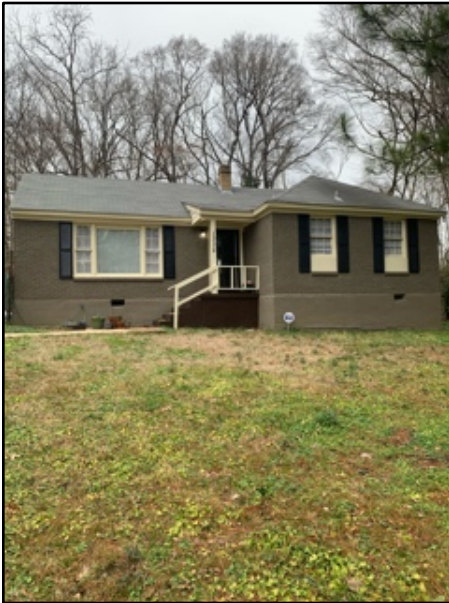
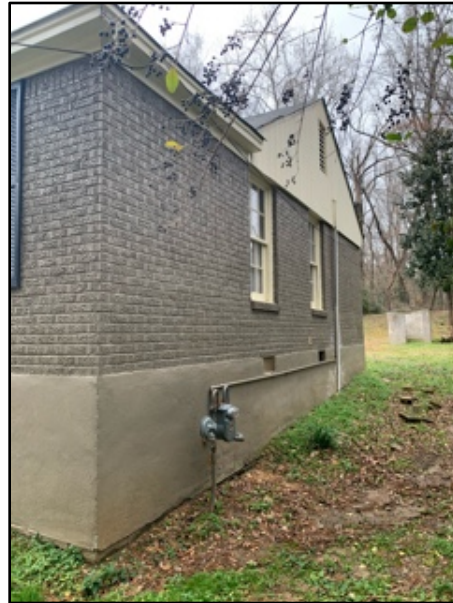
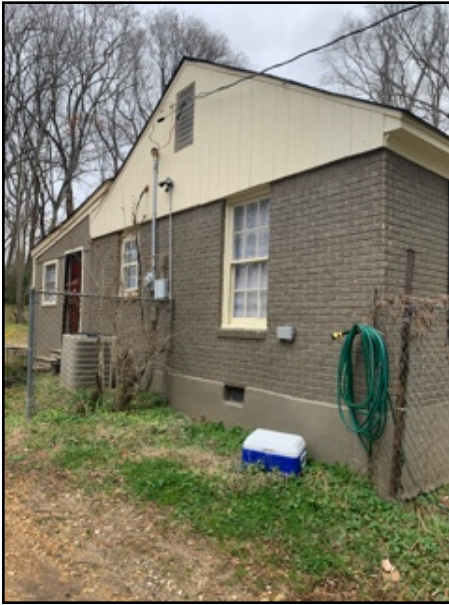
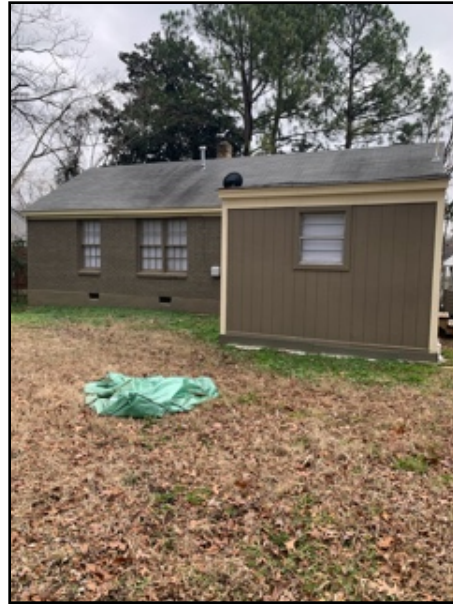
Comment 2:
General pictures of exterior.

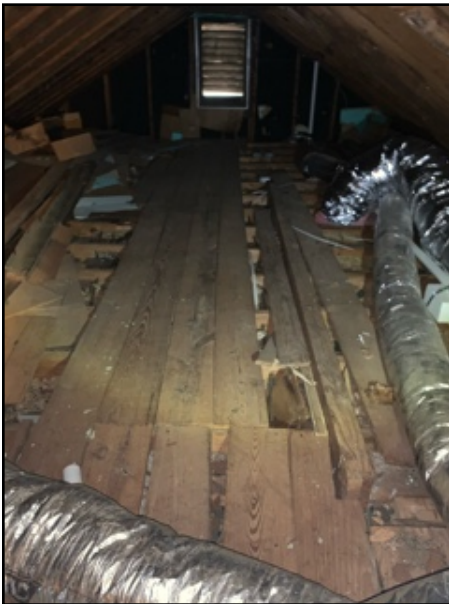
Figure 3-1

Attic Entry:	Hallway
Roof Framing Type:	Joist and Rafters
	Condition: Satisfactory
Roof Deck Material:	Solid Wood Plank
	Condition: Satisfactory
Insulation:	Blown In Fiberglass, Blown In Cellulose
	Condition: Marginal

Comment 3:
Additional insulation is needed in attic.

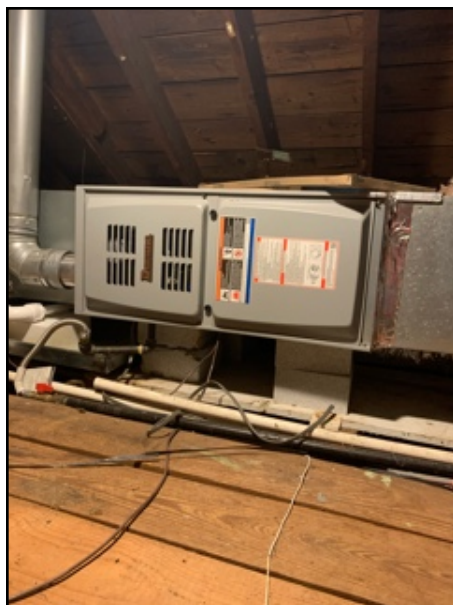
Figure 5-1

Comment 5:
Heat operating as intended.
Register temps above 105 degrees

Furnaces over 10 years old should be checked, cleaned and serviced yearly by a licensed contractor.

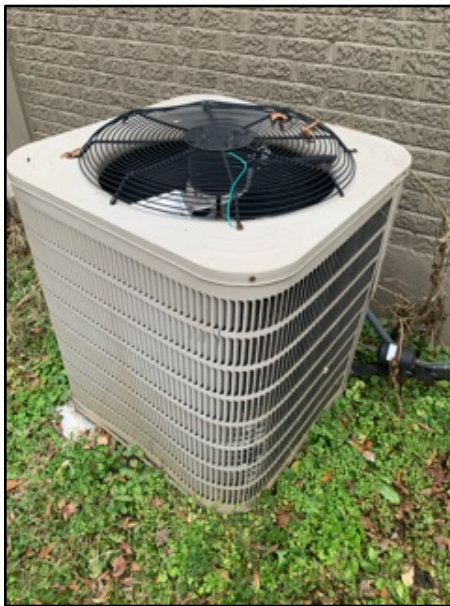
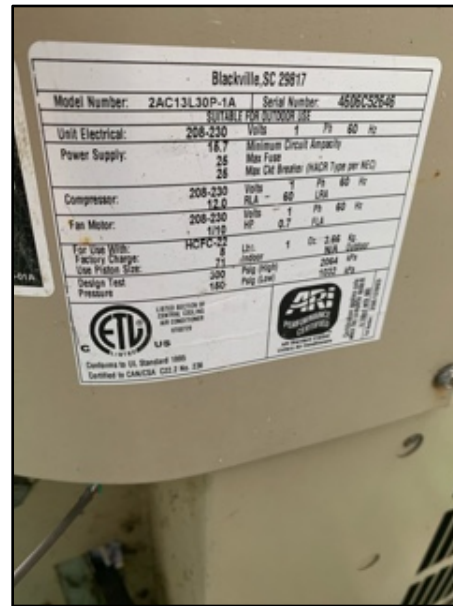
Could not check operation of air conditioning due to outside temperature being below 60° Although unit looked to be in serviceable condition.

Air conditioners over 10 years old and heat pumps over 5 years old should be checked, cleaned and serviced yearly by a licensed contractor.

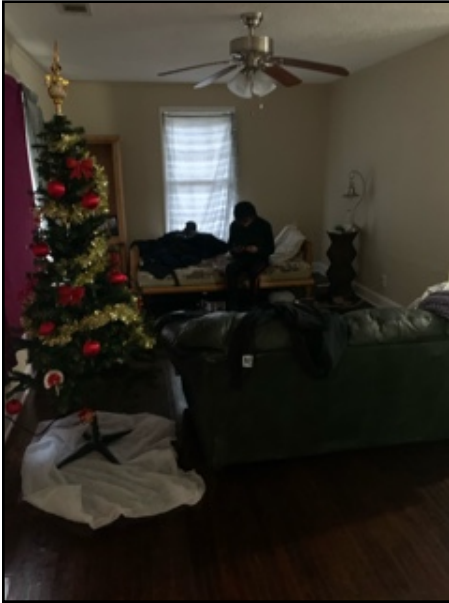
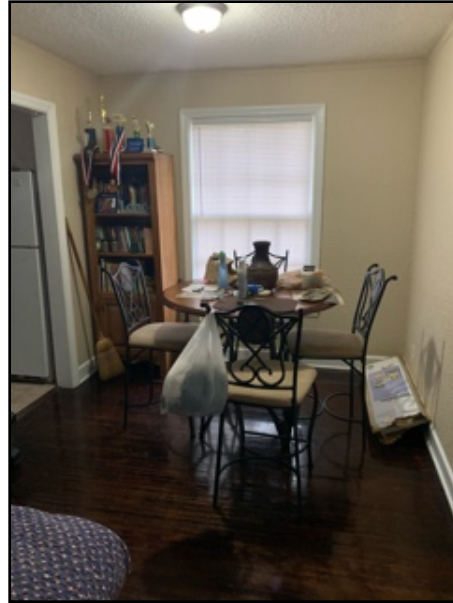
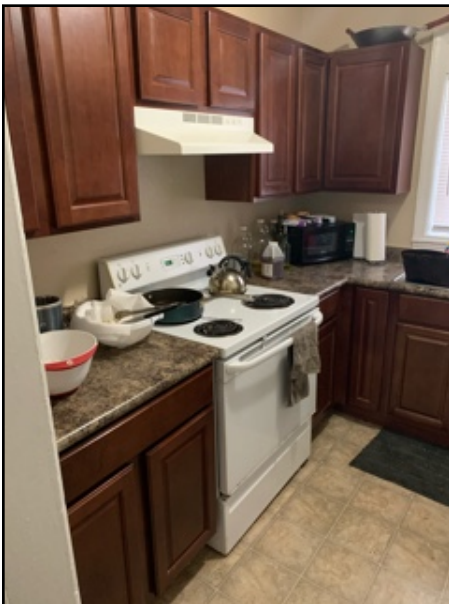
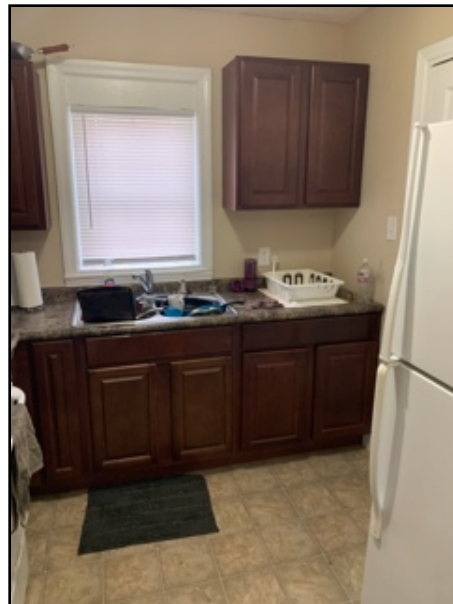
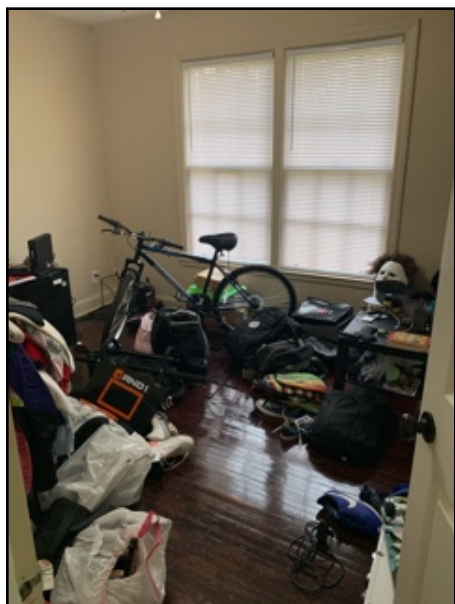
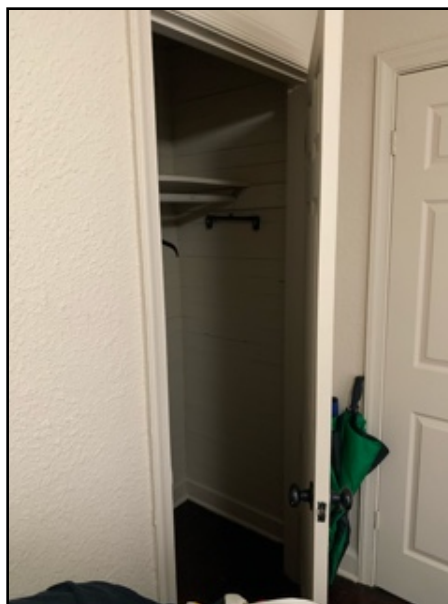
Comment 10:
General pictures of interior.

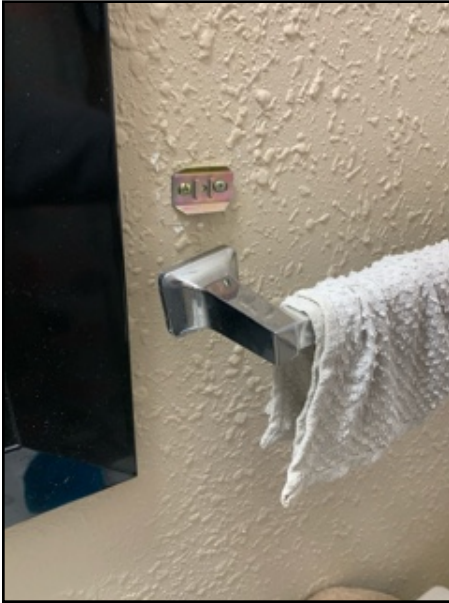
Figure 12-1

Towel bar needs to be reattached to wall in bathroom.

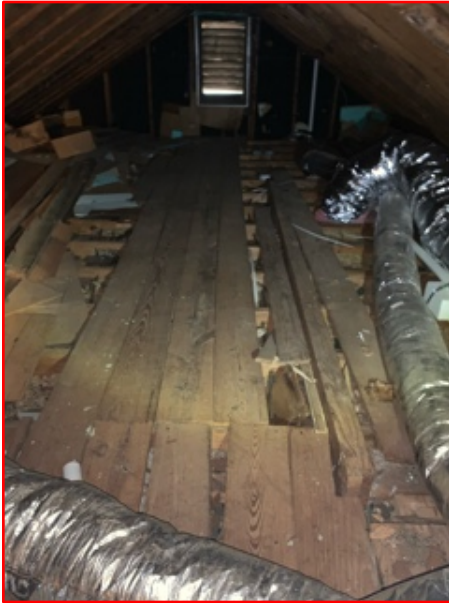
Figure 3-1

1) Additional insulation is needed in attic.

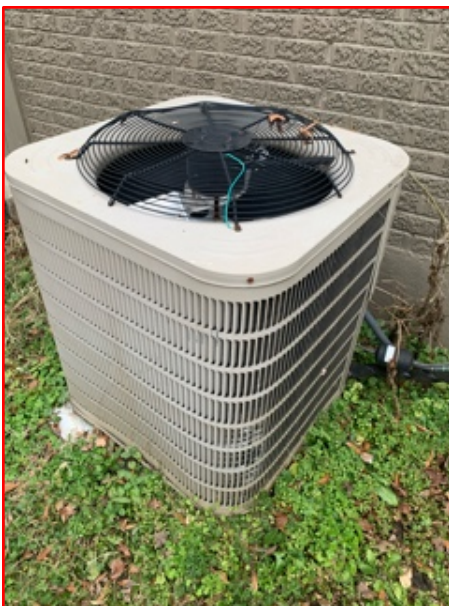
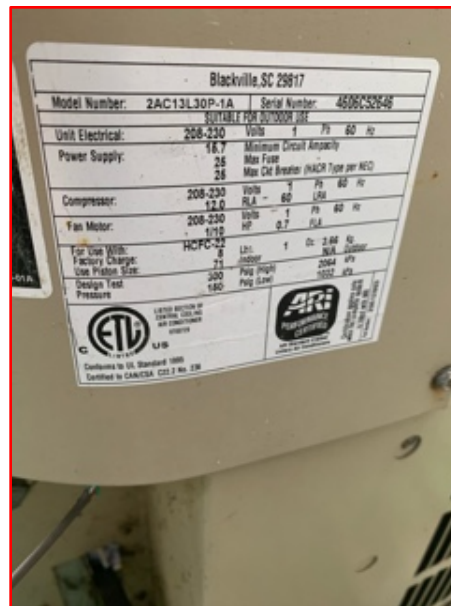
2) Could not check operation of air conditioning due to outside temperature being below 60° Although unit looked to be in serviceable condition.

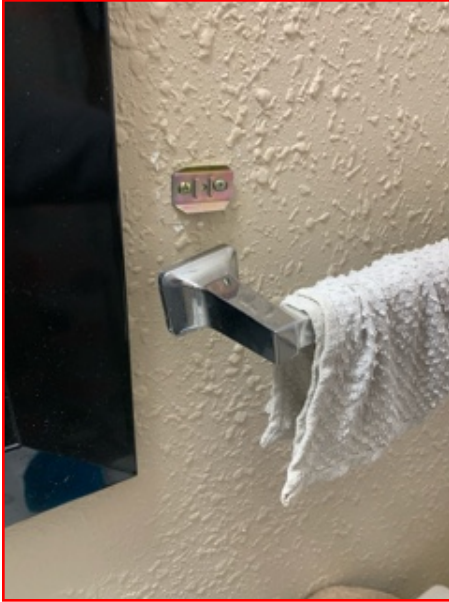
Figure 12-1

5) Towel bar needs to be reattached to wall in bathroom.
